## Stucco Surveys Using Infrared Thermography

Robert Scherer  
Building Diagnostics Group

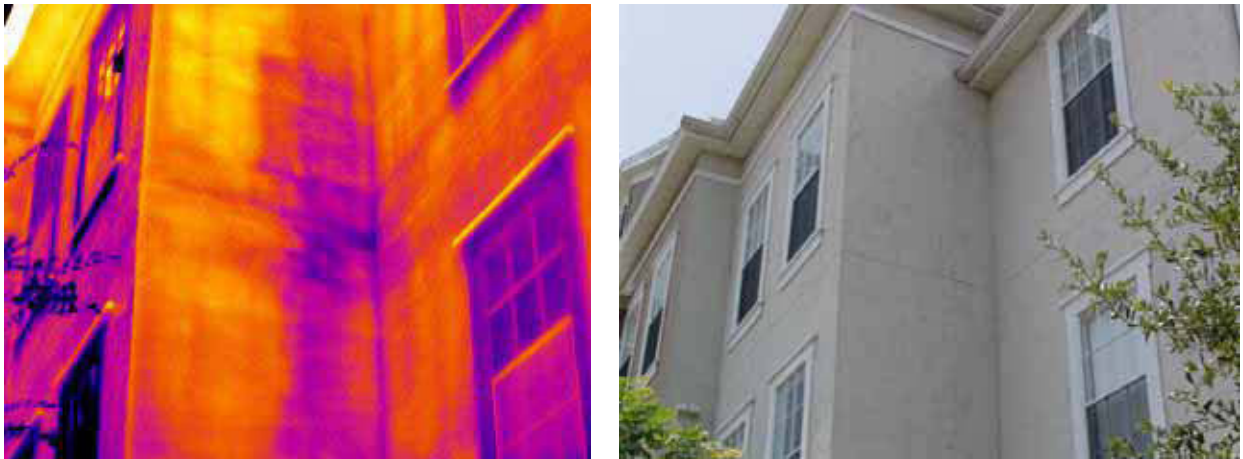
*Figure 1. Thermogram/photo showing damaged sheathing behind stucco system*

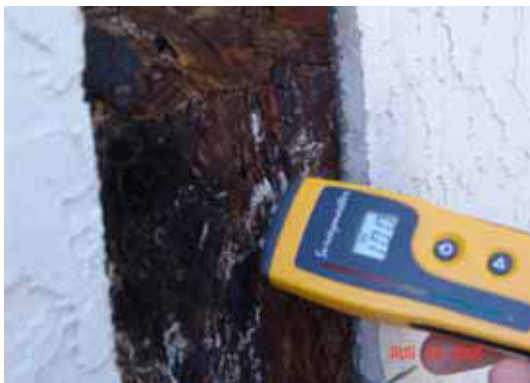
*Figure 2. Test cut determined 100% moisture readings using hand held moisture meter.*

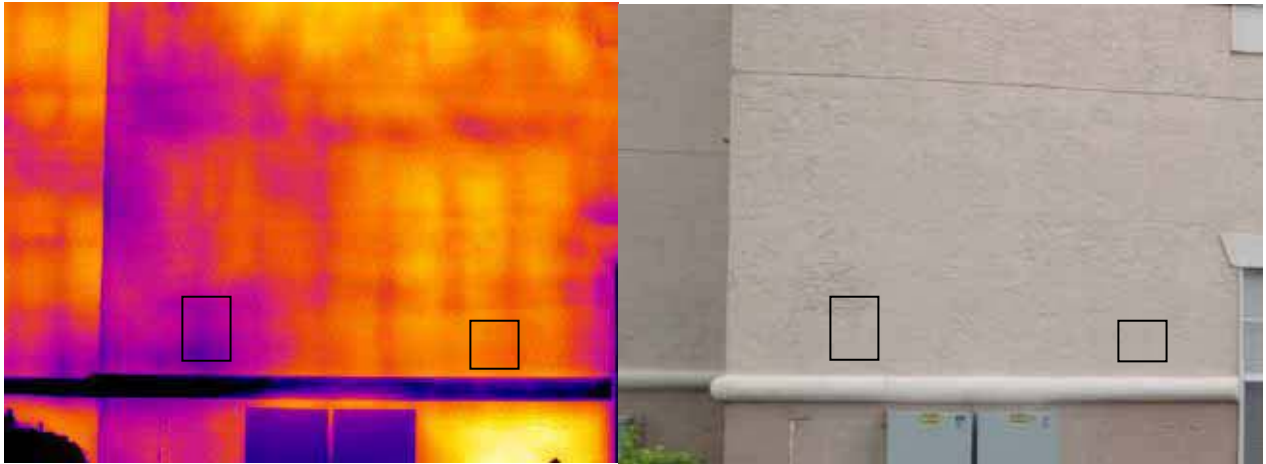
*Figure 3. Thermogram/photo showing damaged sheathing behind stucco system*

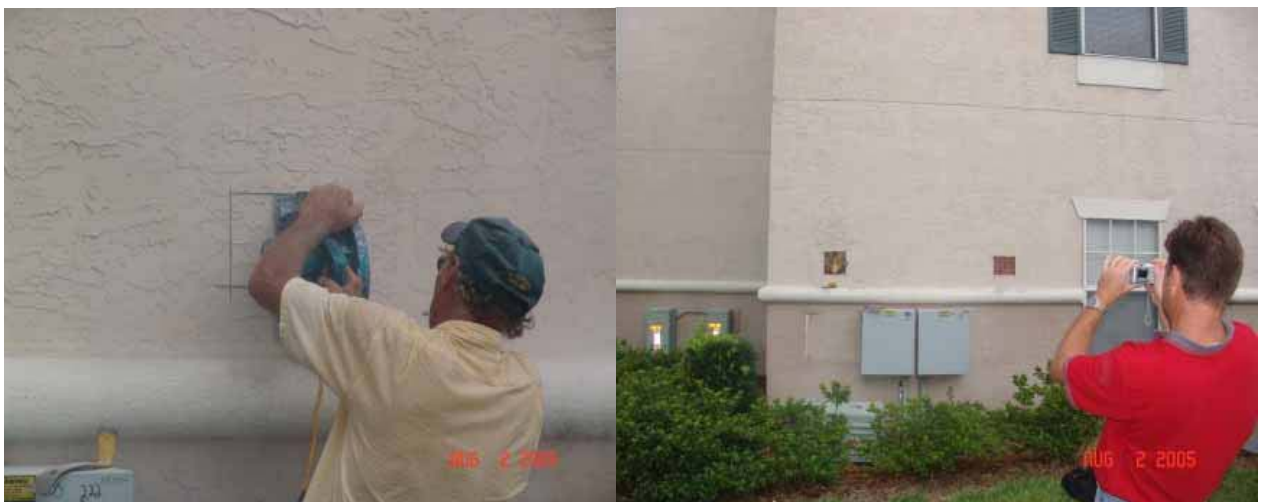
*Figure 4. Test cuts are performed to determine a baseline for interpretation*

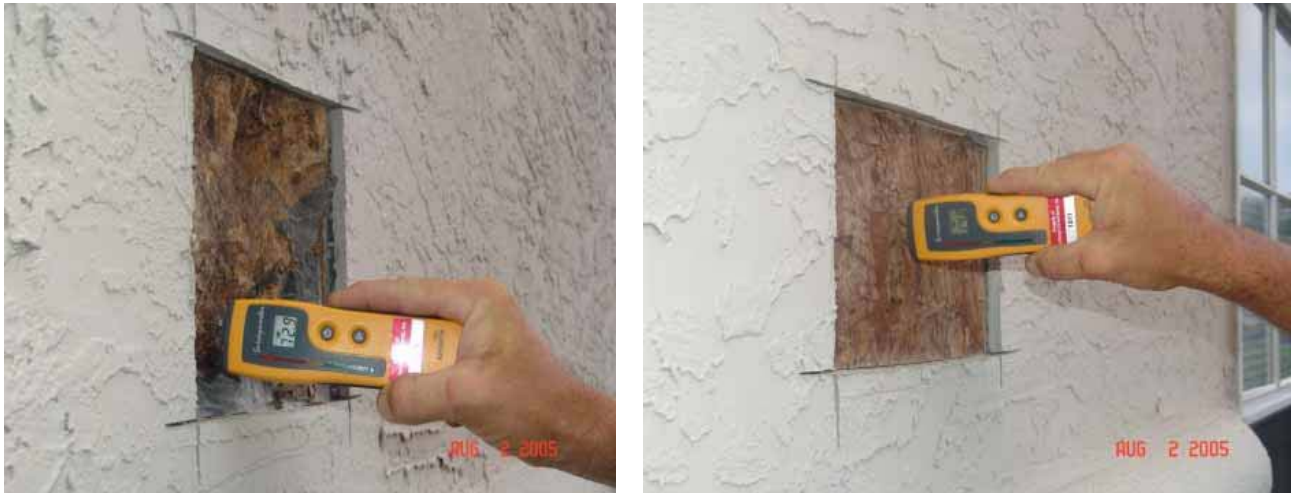
*Figure 5. Moisture readings are then taken to confirm IR findings; left photo has 72.9% moisture, right photo has 14.8%*

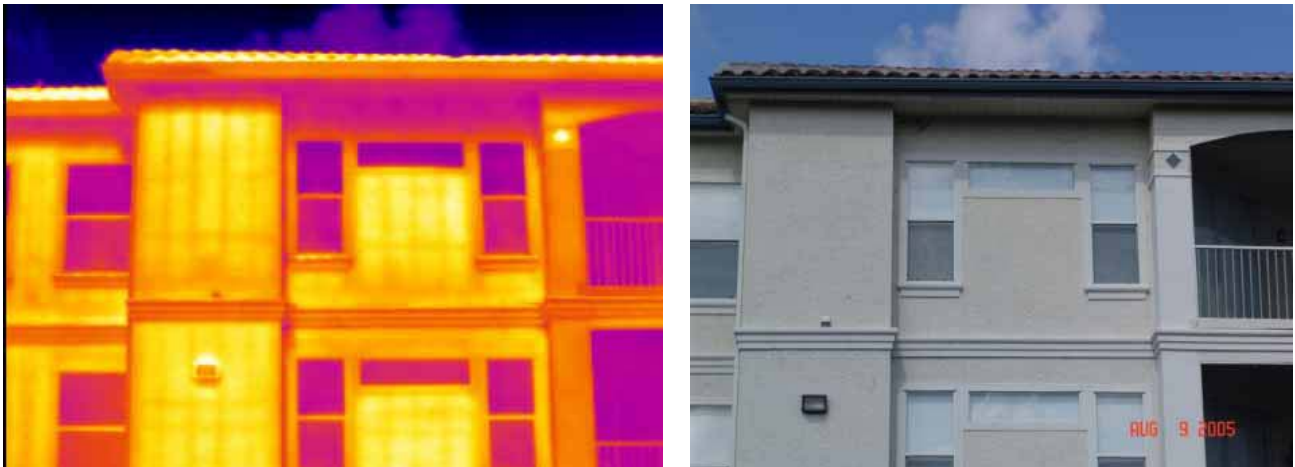
*Figure 6. Thermogram/photo showing no anomalies*

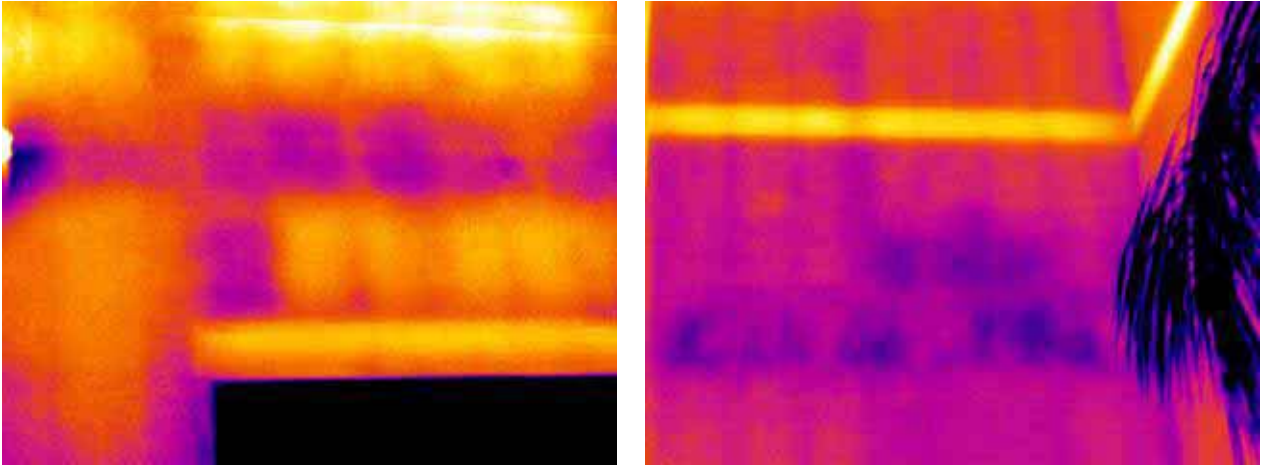
Many building conditions can also cause false readings. Multi-story wood framing buildings will have 12 to 24 inch floor joists in between each floor. AC ducts, plumbing, and other systems are located in this space. Leaking air ducts can sub-cool the space and will show up as possible moisture in the exterior cladding. (see example below) We generally discount these areas unless the delta-T is extreme.

*Figure 7. Images of false readings*
