IR Text Comment	Value
Location	Building 1502
Sub location	West Elevation
Fault	Moisture Confirmed

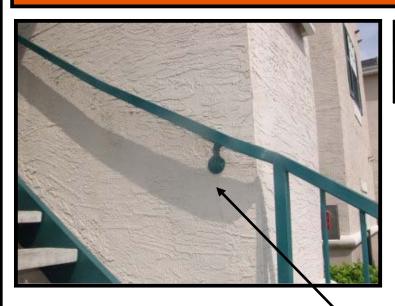
IR Text Comment	Value
Location	Building 12
Sub location	East Stairway
Fault	Anomaly

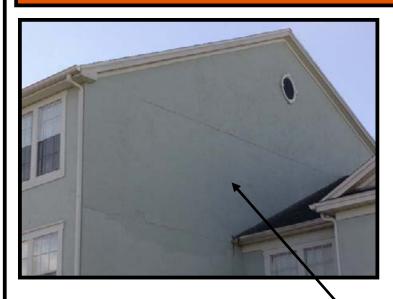
IR Text Comment	Value
Location	Building 2
Sub location	West Gable End
Fault	Damage Confirmed

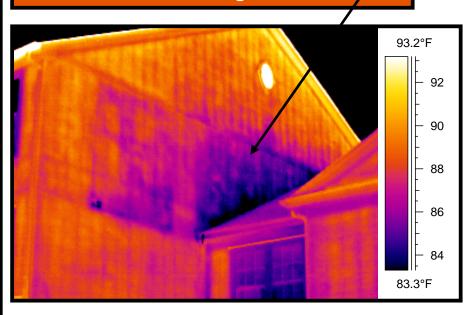
IR information	Value
Date of creation	8/10/2008
Time of creation	10:25:11 AM
File name	lr_1334.jpg
Camera type	B20 NTSC
Camera serial number	21802983
Camera lens	24
Label	Value
IR : max	100.1°F
IR : min	53.9°F

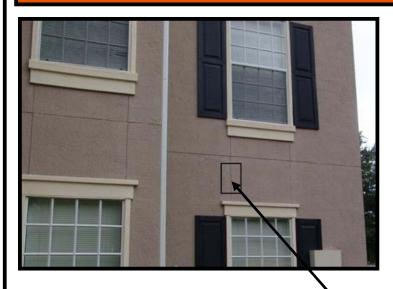
IR Text Comment	Value
Location	Unit 604
Sub location	West Elevation
Fault	Anomaly

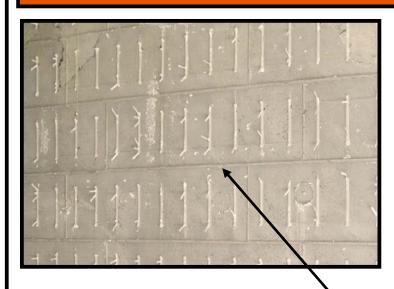
IR Text Comment	Value
Location	Unit 410
Sub location	Master Bedroom
Fault	Post Water Test - Failure

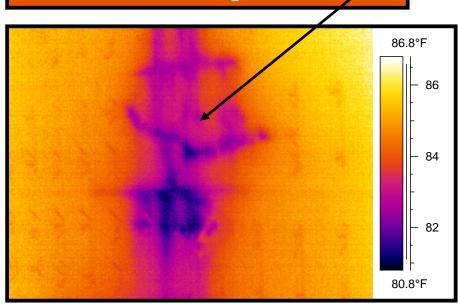
Value
9/20/2007
5:27:12 PM
lr_1619.jpg
B20 NTSC
21802983
24
Value
86.8°F
80.9°F

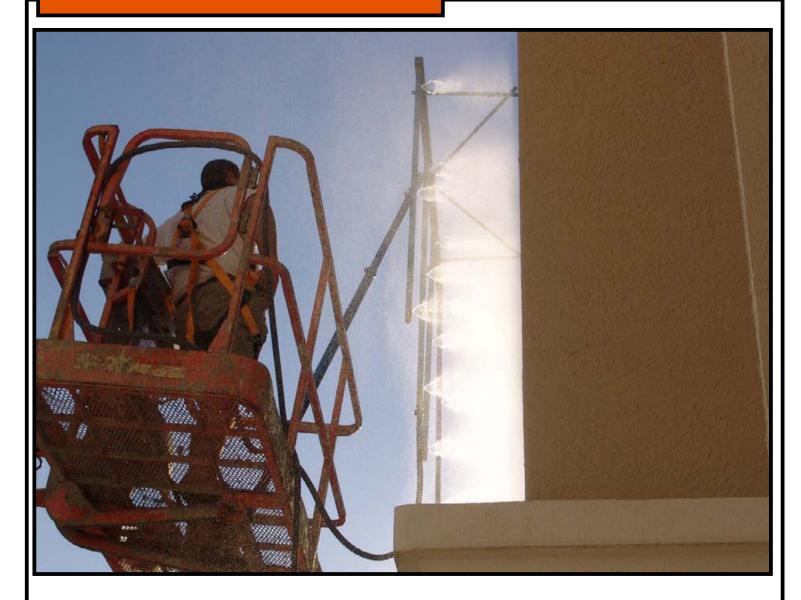
Water Infiltration Testing

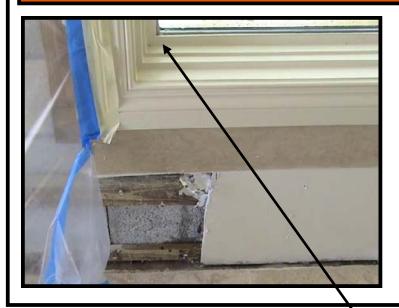
IR Text Comment	Value
Location	Dining Room Test #1
Sub location	Lower Left Corner
Fault	Post Water Test - Failed

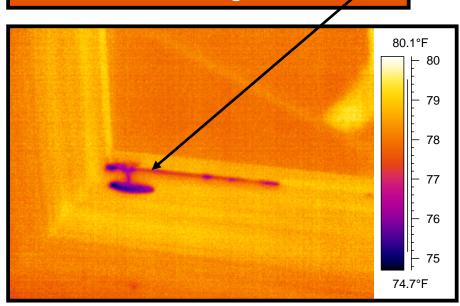
IR information	Value
Date of creation	6/24/2006
Time of creation	2:25:09 PM
File name	lr_0733.jpg
Camera type	B20 NTSC
Camera serial number	21802983
Camera lens	24
Label	Value
IR : max	79.7°F
IR : min	74.9°F

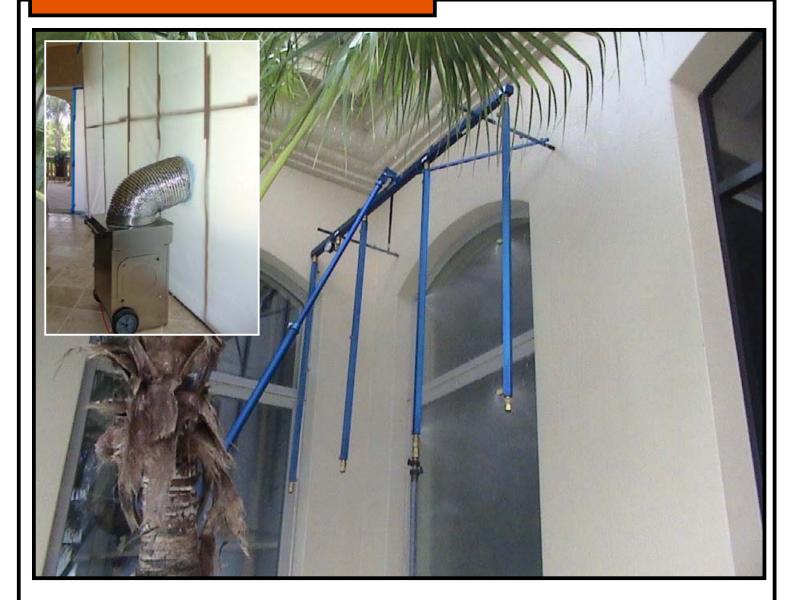
Water Infiltration Testing

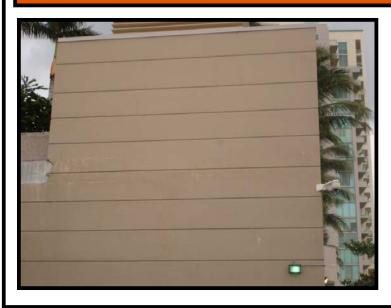
IR Text Comment	Value
Location	East Elevation
Sub location	Convention Center East Wall
Fault	Incomplete Cell Fills

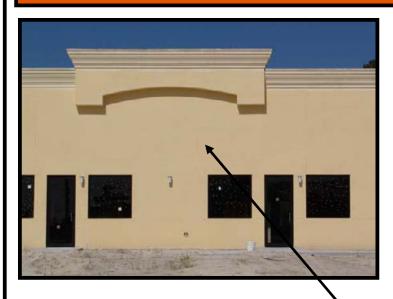
IR Text Comment	Value
Location	19425 Metro Parkway
Sub location	Town Center Plaza
Fault	Mulitple Incomplete Cell Fills

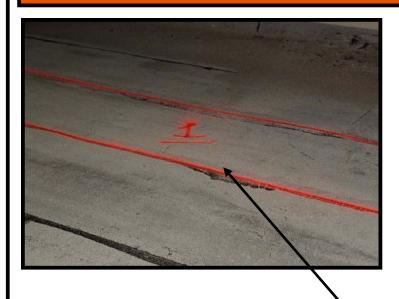
IR Text Comment	Value
Location	North Tower
Sub location	West End - Spot #1
Fault	Anomaly - Core Sample Location

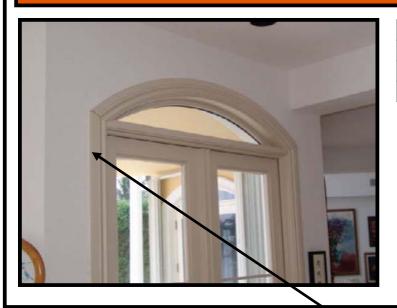
IR Text Comment	Value
Location	Living Room
Sub location	Rear French Door
Fault	Moisture Detected

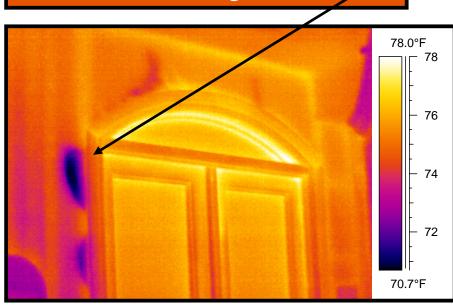
IR information	Value
Date of creation	10/6/2007
Time of creation	3:02:01 PM
File name	lr_1937.jpg
Camera type	B20 NTSC
Camera serial number	21802983
Camera lens	24
Label	Value
IR : max	78.3°F
IR : min	70.6°F

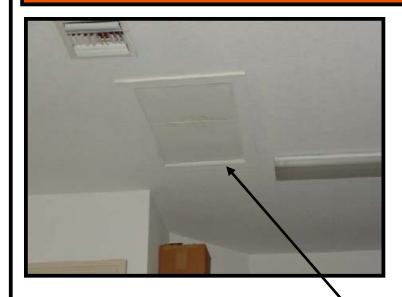
IR Text Comment	Value
Location	Garage
Sub location	Ceiling - West Wall
Fault	Moisture Detected

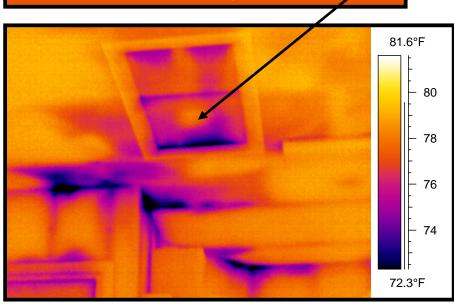
Value
10/6/2006
3:13:18 PM
lr_1944.jpg
B20 NTSC
21802983
24
Value
79.7°F
69.8°F

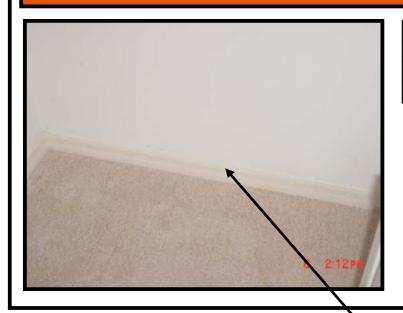
IR Text Comment	Value
Location	Guest Bedroom
Sub location	Closet
Fault	Moisture Detected

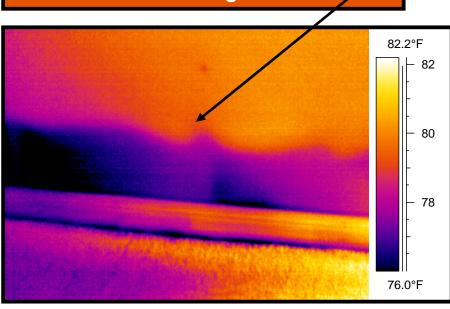
IR information	Value
Date of creation	4/19/2008
Time of creation	3:35:03 PM
File name	lr_0096.jpg
Camera type	B20 NTSC
Camera serial number	21802983
Camera lens	24
Label	Value
IR : max	82.3°F
IR : min	75.1°F

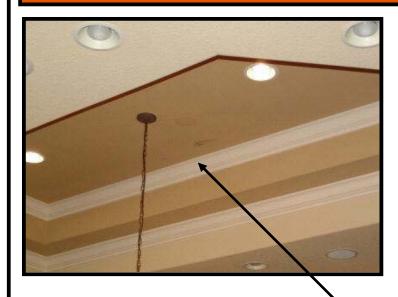
IR Text Comment	Value
Location	Dining Room
Sub location	Ceiling
Fault	Mositure Detected

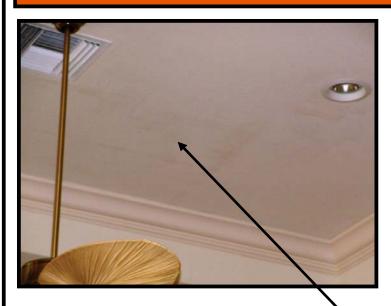
IR Text Comment	Value
Location	Family Room
Sub location	Ceiling
Fault	Approx. 16 SF Missing Insulation

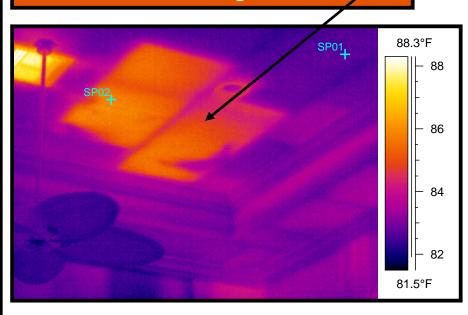
IR information	Value
Date of creation	4/2/2007
Time of creation	3:27:57 PM
File name	lr_0154.jpg
Camera type	B20 HS NTSC
Camera serial number	25300633
Camera lens	24
Label	Value
IR : max	88.5°F
IR : min	81.7°F
SP01	82.7°F
SP02	86.0°F

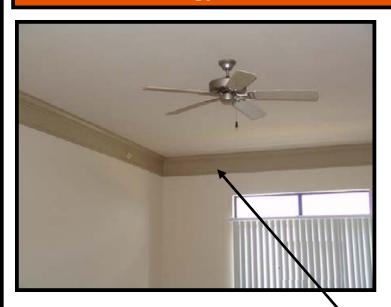
IR Text Comment	Value
Location	Building 4
Sub location	Unit 419
Fault	No Attic Insulation

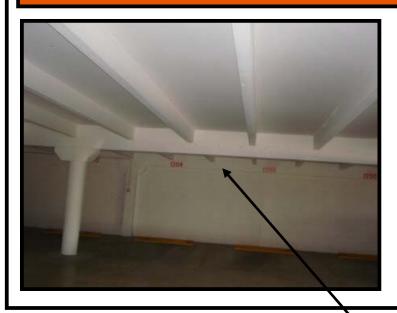
IR Text Comment	Value
Location	Parking Garage
Sub location	East Side
Fault	Confirmed Moisture

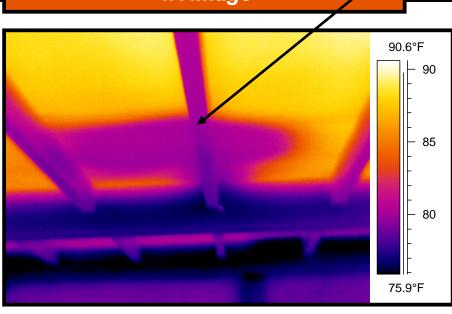
Value
11/3/2007
9:30:50 PM
lr_0892.jpg
B20 NTSC
21802983
24
Value
90.0°F
74.8°F

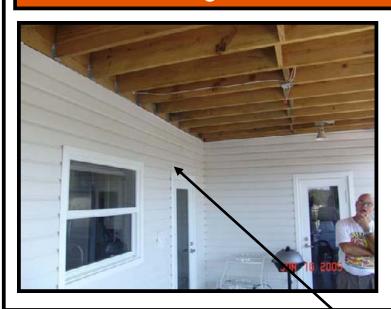
IR Text Comment	Value
Location	145 West Street
Sub location	West Elevation
Fault	Water Damage - Confirmed

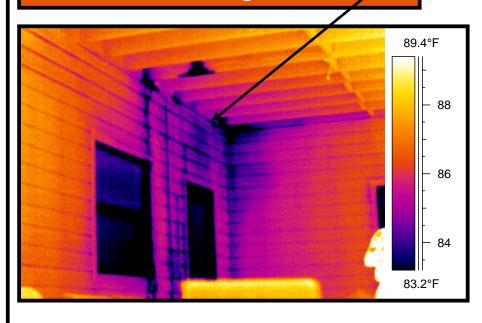
IR information	Value
Date of creation	6/16/2005
Time of creation	2:47:04 PM
File name	lr_0526.jpg
Camera type	B20 NTSC
Camera serial number	21802983
Camera lens	24
Label	Value
IR : max	91.9°F
IR : min	79.9°F

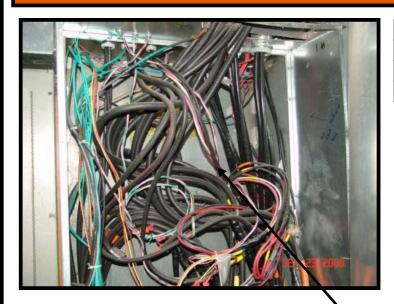
IR Text Comment	Value
Location	Distribution Room 4
Sub location	Junction Box Panel FF
Fault	NETA - REPAIR CODE A

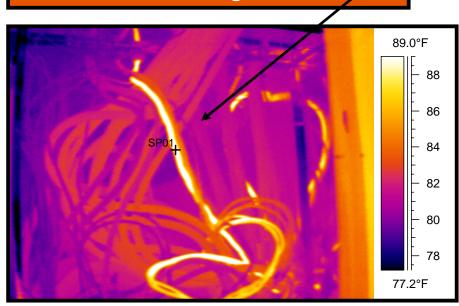
IR information	Value
Date of creation	9/23/2008
Time of creation	9:30:39 AM
File name	lr_0528.jpg
Camera type	B20 HS NTSC
Camera serial number	25300633
Camera lens	45
Label	Value
IR : max	93.4°F
IR : min	71.1°F
SP01	91.3°F

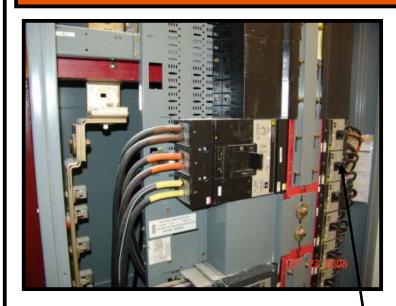
IR Text Comment	Value
Location	Distribution Room G
Sub location	Switch Panel 9
Fault	NETA - REPAIR CODE A

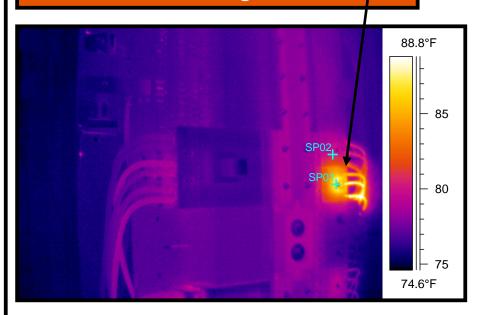
IR information	Value
Date of creation	9/23/2008
Time of creation	11:23:30 AM
File name	lr_0548.jpg
Camera type	B20 HS NTSC
Camera serial number	25300633
Camera lens	45
Label	Value
IR : max	89.7°F
IR : min	74.5°F
SP01	84.7°F
SP02	80.9°F

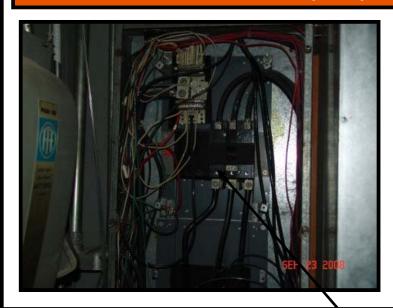
IR Text Comment	Value
Location	Distribution Room A
Sub location	Panel F
Fault	NETA - REPAIR CODE A

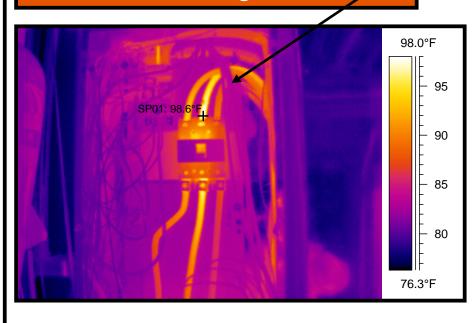
IR information	Value
Date of creation	9/23/2008
Time of creation	10:01:42 AM
File name	lr_0535.jpg
Camera type	B20 HS NTSC
Camera serial number	25300633
Camera lens	45
Label	Value
IR : max	98.9°F
IR : min	76.2°F
SP01	98.6°F
